Casino Winner Technical Bulletin

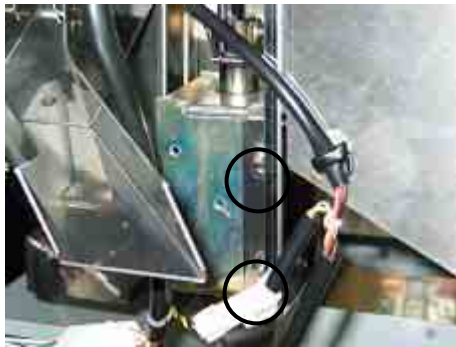
It has come to our attention that a small number of customers have experienced a problem with their new Casino Winner pusher from Brent/Namco whereby error code 5-13 is displayed, causing the machine to lock up until it is reset. We have discovered that the position of the payout solenoid is critical to its effective operation and may need to be adjusted on your machine if this error is experienced. This is a simple operation taking just a few minutes and full instructions are provided below. Please contact our Customer Service dept. on 02083246120 should you require further information.

1. Refer to p147 of the operation manual if necessary.
2. Slacken off the two retaining bolts holding the solenoid as shown in the photograph below.
