TECHNICAL BULLETIN

POINT BLANK 2

Two problems have been identified on games with the following serial numbers:-

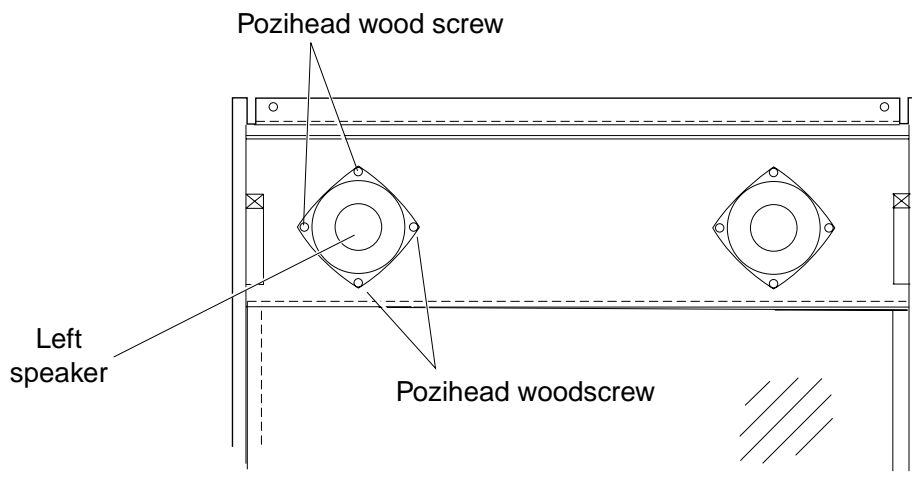
The loudspeakers have been wired 'out of phase' resulting in a loss of bass tone.

3. Remove 4 off pozi head wood screws and remove the left speaker only sufficiently to access the speaker connections.
Note: Take care not to damage the speaker cone.

4. Disconnect the speaker.
5. Cut off the 0.110" (smallest) receptacle from the white/violet wire and replace it with the supplied 0.187" receptacle.
6. Cut off the 0.187" receptacle from the white/red wire and replace it with the supplied 0.110" receptacle.
7. Reconnect the speaker and reassemble in reverse order.
