TECHNICAL BULLETIN

MACHINE : POCKET MONEY

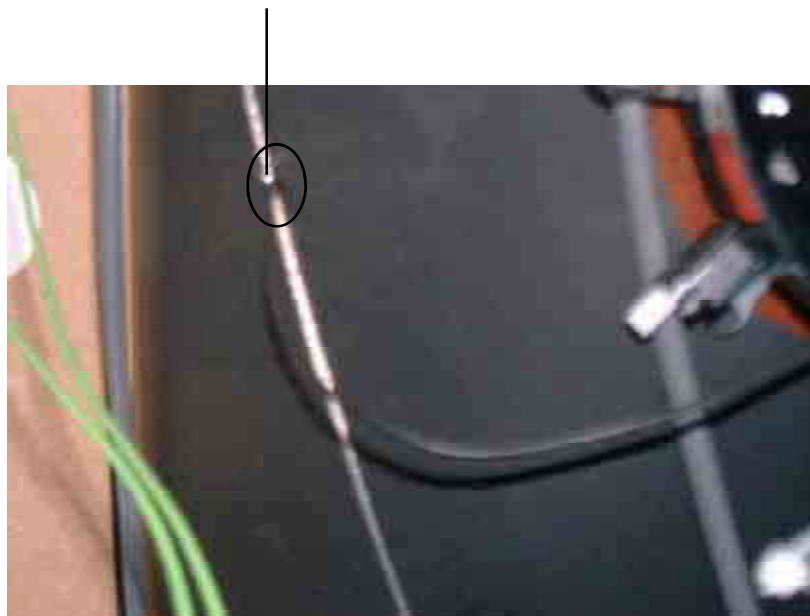
FAULT : Monitor chassis failure caused by poor earth connection on crt because the connection has been wrapped rather than soldered. Subsequent EHT flashover causes failure of components D8 and D14 on the main chassis.

SOLDER AT THIS POINT

SOLUTION : Remove the earth connection that runs from the neck pcb to the tube strap at the tube end. Pre-tin the end of the earth lead and the tube strap and solder together.
